MISSISSIPPI ENVIRONMENTAL GEOLOGY

David T. Dockery III and David E. Thompson

Mississippi Department of Environmental Quality
Office of Geology
Second Edition, 2019

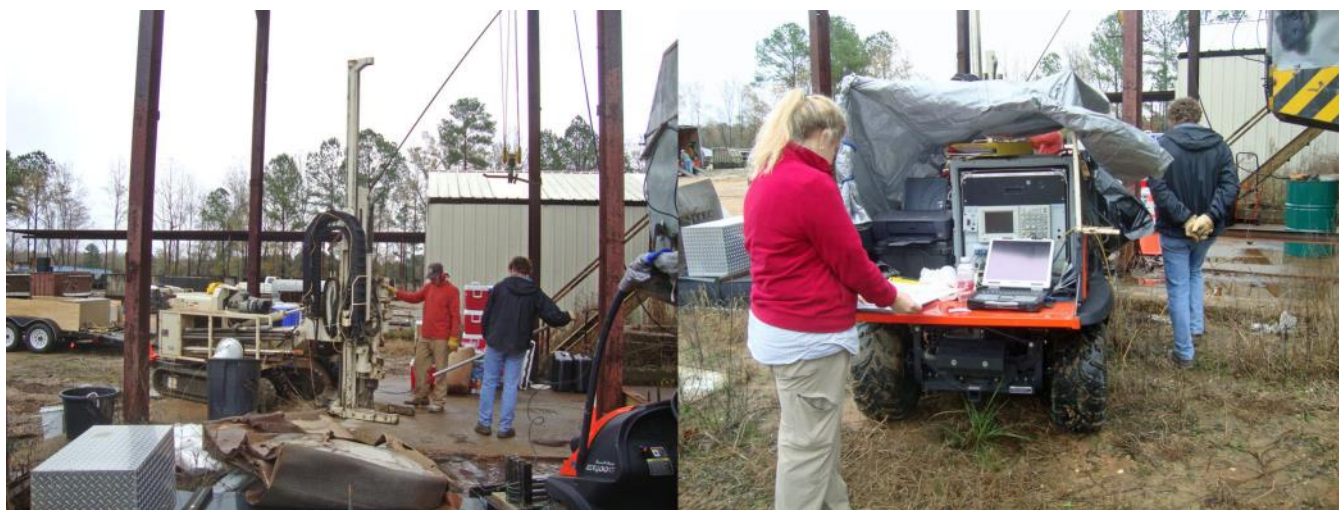
Figure 442. At left, a track-mounted direct-push device has hammered through the concrete slab of a metal shed and is now hammering a LIF probe through the Pearl River alluvium at the Sonford Superfund site at Flowood, Mississippi. At right, site engineer Darci Scherbak checks the 2010 plume map against the real-time LIF log for 2012. Pictures (digital; Image 2273) were taken on December 5, 2012.

Once the LIF log was completed for a location, a track-mounted direct-push coring rig sampled the alluvial section at the same spot for laboratory analysis (**Figure 441**). **Figure 442** shows the operation of the direct-push LIF rig. **Figure 443** shows a LIF probe and a core from a depth of 10-15 feet with dark bands of PCP contaminants. The LIF log printout is given in **Figure 444** and the 2010 PCP plume map in **Figure 445**.

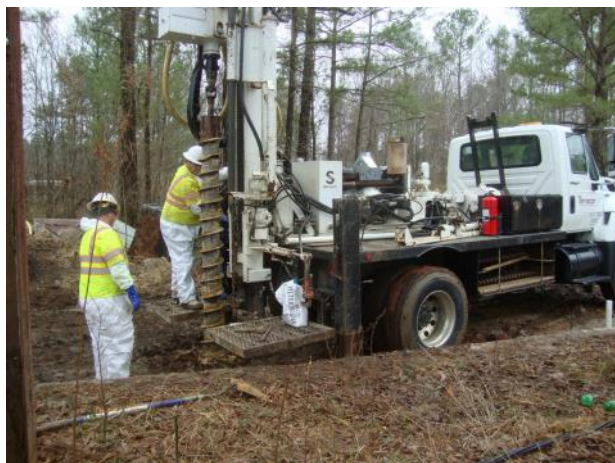
Figure 448. Auger drilling of a 25-foot-deep screened well in the pollutant plume at the Sonford site. Picture (digital; Image 2477) was taken on February 3, 2014.

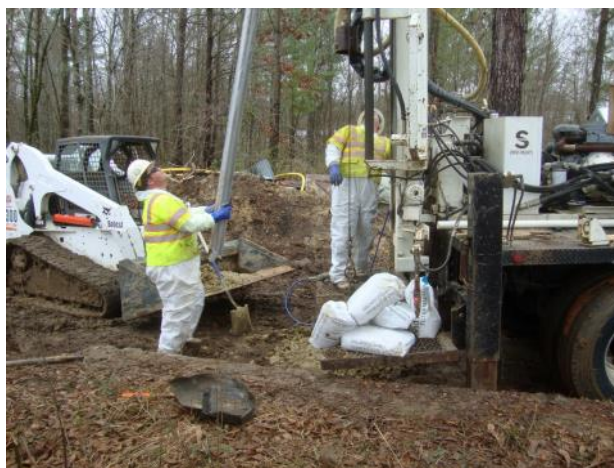
Figure 449. Once the plug at the bottom of the bit is punched out, the screened well casing is lowered down the hollow center of the auger flight. Sand bags, containing the sand packing, sit next to the bore hole. Picture (digital; Image 2478) was taken on February 3, 2014.

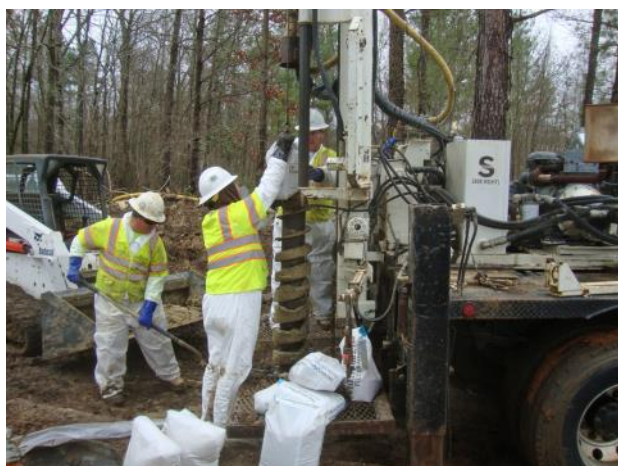
Figure 450. Once the screened well casing is in place, the auger flights are raised and dismantled in five-foot sections as the sand packing is poured down the hole, filling the gap between the casing and formation left by the removed pipe. Picture (digital; Image 2479) was taken on February 3, 2014.

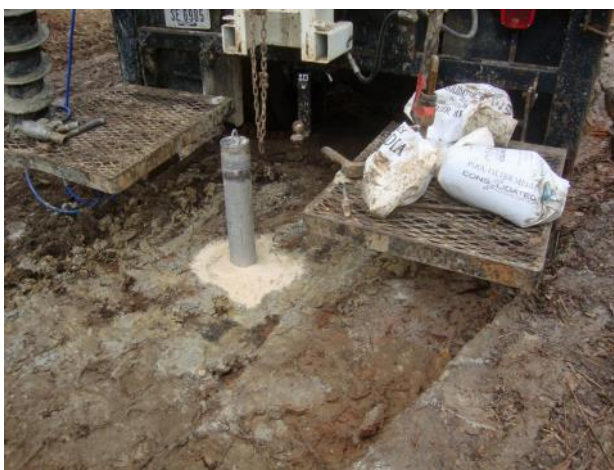
Figure 451. Screened well casing and sand packing in place within the pollutant plume at the Sonford sit. Picture (digital; Image 2480) was taken on February 3, 2014.

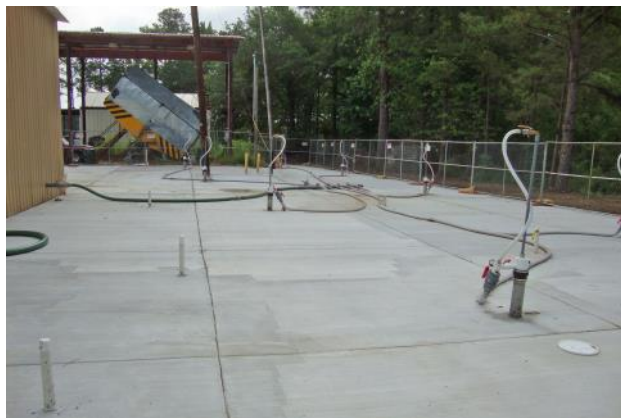
Figure 452. Zone 1 well field at the Sonford site. Hoses are attached to withdrawal wells; vent wells are at left. Picture (digital; Image 2481) was taken on June 13, 2014.

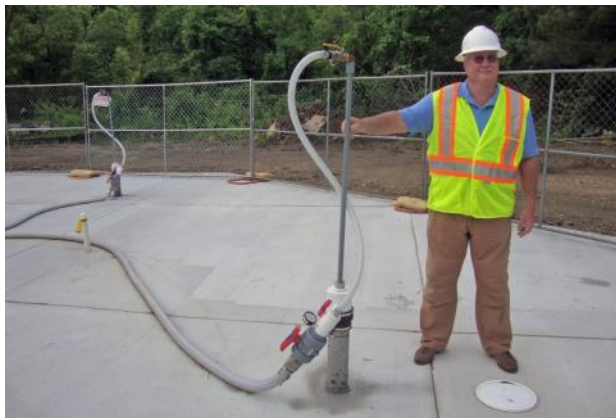
Figure 453. Richard Ball stands beside a withdrawal well at the Sonford site. Picture (digital; Image 2482) was taken on June 13, 2014.

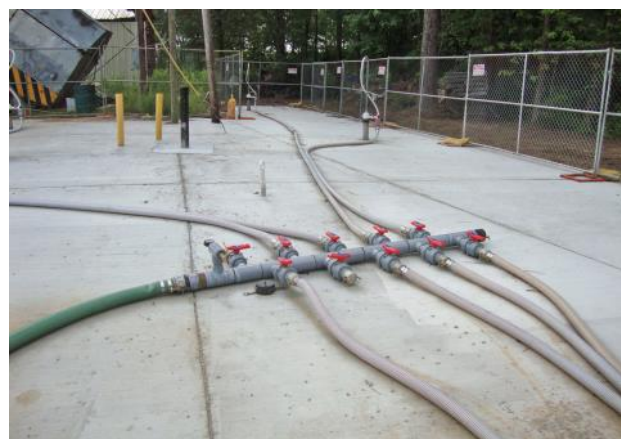
Figure 454. Mainline connection leading to product separators in metal building. Picture (digital; Image 2483) was taken on June 13, 2014.

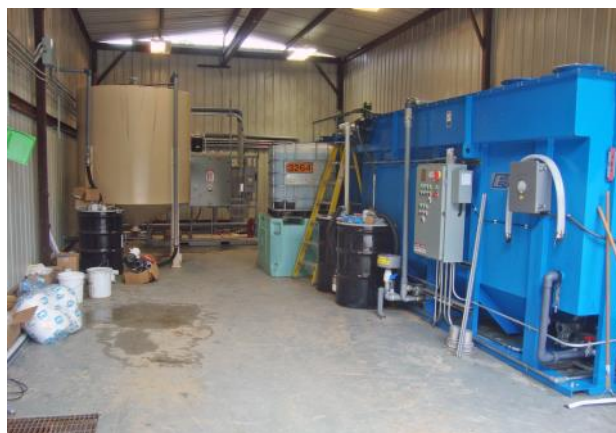
Figure 455. Surfactant container (with red label at back) and product separators (right front in blue) and product storage container (brown at left) in metal building at the Sonford site. Picture (digital; Image 2484) was taken on June 13, 2014.

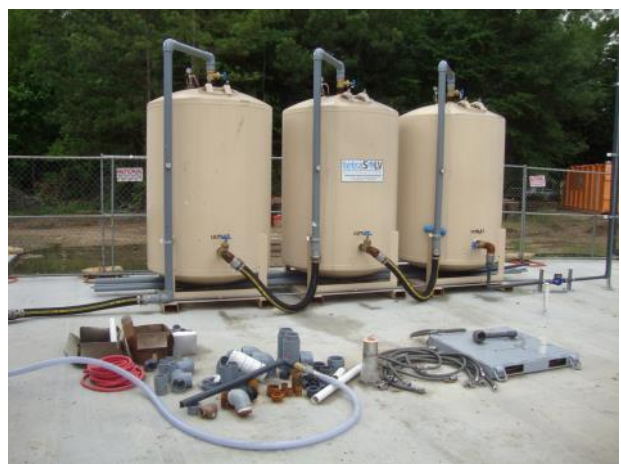
Figure 456. Carbon-filter tanks capable of bringing separated water up to drinking water standards before it is returned to the aquifer in the injection wells. Picture (digital; Image 2485) was taken on June 13, 2014.

arators, and product storage tank. **Figure 456** shows the carbon-filter tanks for the separated water, which, once filtered, is returned to the aquifer. According to the contractors, the filtered water was clean enough the meet drinking water standards.

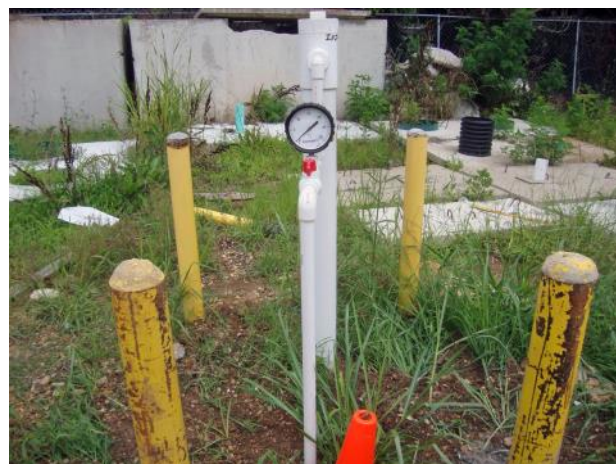
Figure 457. Injection well with pressure gauge. Injection wells were placed at the margin of the plume to drive pollutants toward the withdrawal wells. Picture (digital; Image 2486) was taken on June 13, 2014.

Figure 457 shows one of the injection wells. These wells were placed at the edge of

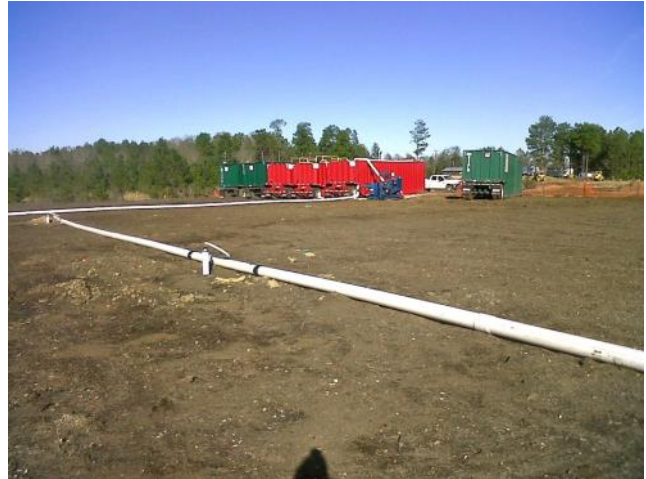
Figure 464. Treating contaminated water at the Impoundment area of the Davis Timber Superfund site in Lamar County, Mississippi. Picture (digital; Image 2175) was taken by Michael Slack on January 12, 2012.

1. Extract Impoundment liquid (estimated to be roughly 100,000 gallons and treat the liquid to remove the dissolved contamination; discharge the clean water back into West Mineral Creek (**Figure 464**).

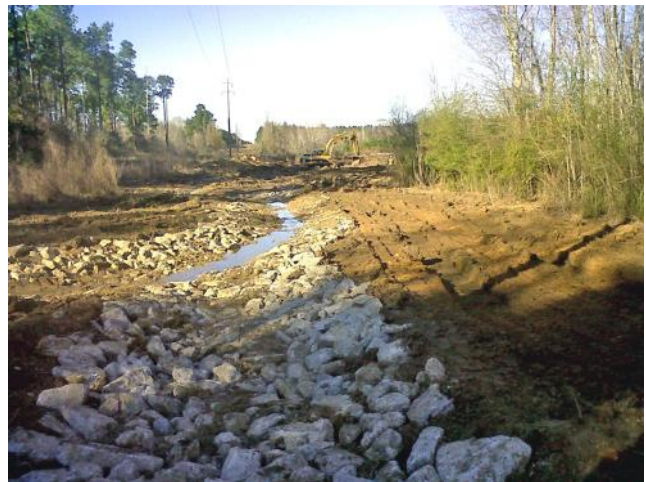
Figure 465. Relocation of West Mineral Creek 200 feet west of its original location at the Davis Timber Superfund site in Lamar County, Mississippi. Picture (digital; Image 2176) was taken by Michael Slack on January 12, 2012.

2. Move a 500- to 1000-foot portion of West Mineral Creek (immediately adjacent to the Impoundment area) approximately 200 feet farther west of its current location (**Figure 465**).

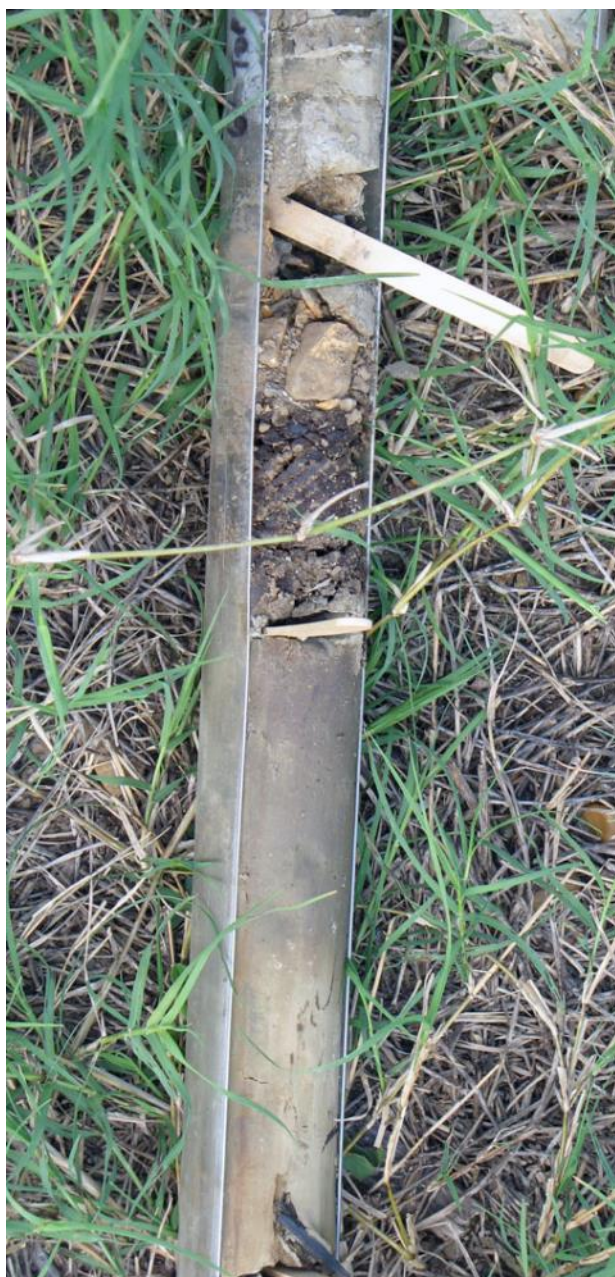
Figure 469. Core with creosote-contaminated alluvium at top and Yazoo Clay at bottom. Picture (digital; Image 2180) was taken by Richard Ball on September 18, 2007.

a series of core holes along the boundary between the disposal cell and Batchelor Creek. The concern was that creosote from the cell had leaked into the creek. Drilling (**Figure 468-469**) found no significant leakage from the disposal cell, indicating that creosote in the creek bottom and banks was the result of a long history of creosote contamination from the plant site. **Figure 470** shows an EPA worker and contract worker taking samples along Batchelor Creek in 2008. **Figure 471** shows creosote oozing from cracks in the Yazoo Clay into the bottom of Batchelor Creek. This picture was instrumental in obtaining EPA funding for an Emergency Response cleanup (**Figure 472**). Creosote can be seen

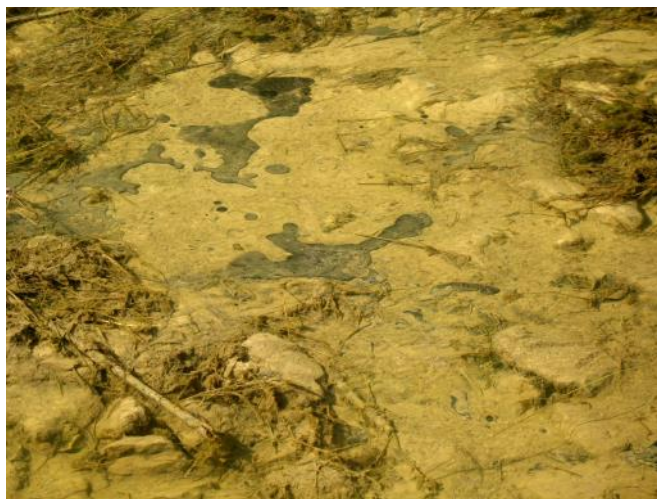
Figure 471. Creosote oozing from fractures in the Yazoo Clay into the bottom of Batchelor Creek. Picture (digital; Image 2182) was taken by Richard Ball on September 8, 2009.

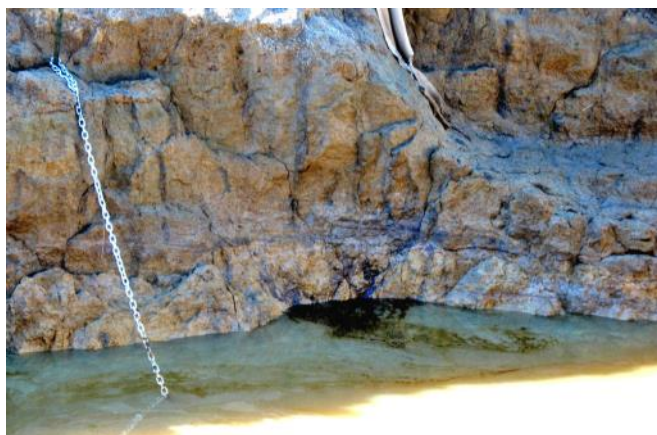
Figure 473. Creosote draining from fractures in the alluvium and underlying Yazoo Clay on the banks of Batchelor Creek. Picture (digital; Image 2184) was taken by Richard Ball on October 20, 2009.

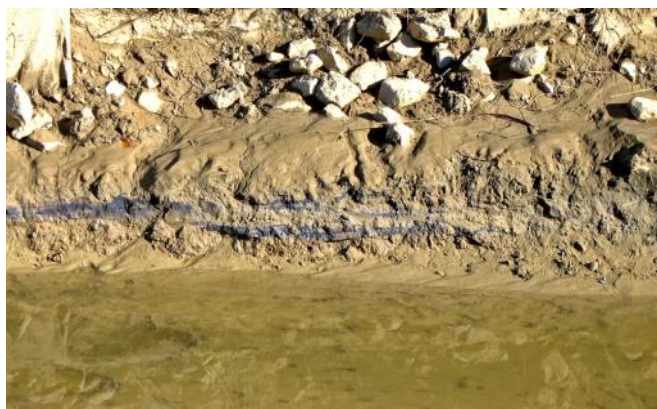
Figure 474. Layers of creosote in the alluvium of Batchelor Creek. Picture (digital; Image 2185) was taken by Richard Ball on October 20, 2009.

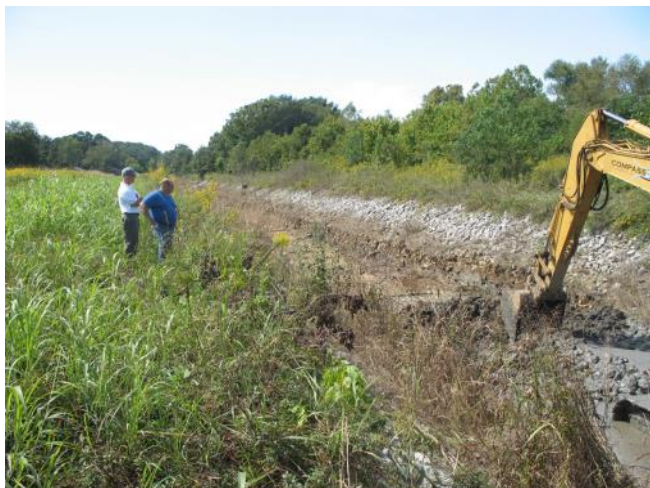
Figure 475. Excavating creosote contaminated soil from the bottom and banks of Batchelor Creek. Picture (digital; Image 2186) was taken by Richard Ball on October 1, 2009.

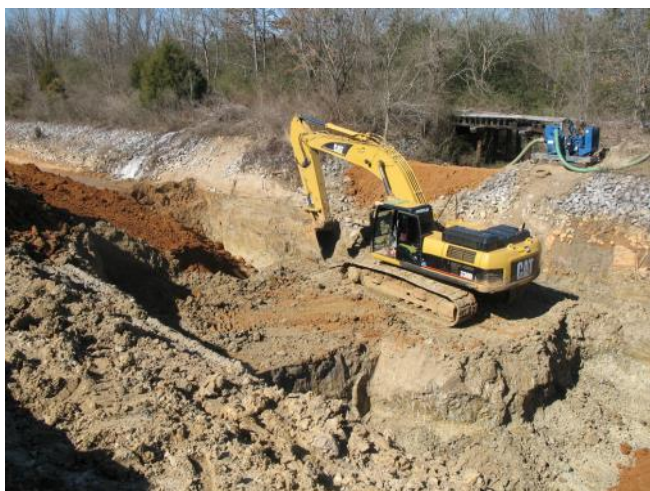
Figure 477. The deepest penetration of creosote into the Yazoo Clay and the deepest excavation of contaminated soil on Batchelor Creek. Picture (digital; Image 2188) was taken by Richard Ball on January 27, 2010.

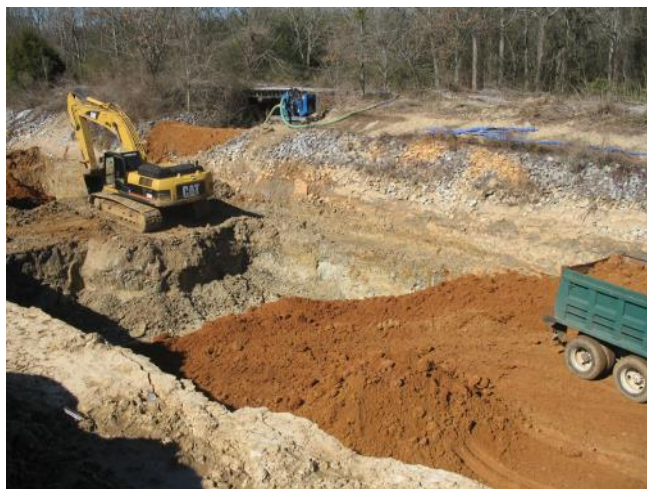
Figure 478. Backfilling with clean soil at the deepest excavation of contaminated material on Batchelor Creek. Picture (digital; Image 2189) was taken by Richard Ball on January 27, 2010.

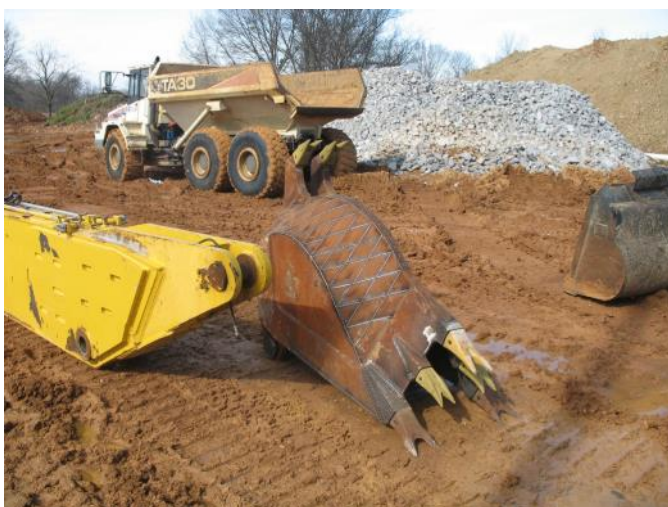
Figure 480. Claw bucket used to dredge the slurry wall between the disposal cell and Bachelor Creek. Picture (digital; Image 2191) was taken by Richard Ball on February 3, 2010.

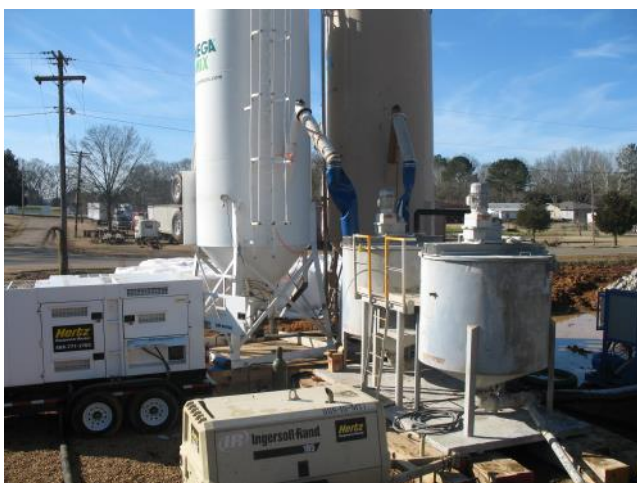
Figure 481. Holding tanks for cement and bentonite to be mixed in equal amounts in a slurry for the slurry wall. Picture (digital; Image 2192) was taken by Richard Ball on February 18, 2010.

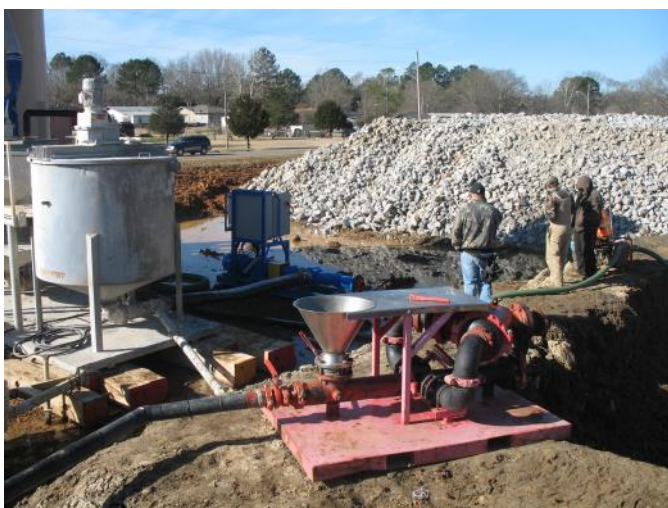
Figure 482. Pumping the slurry mix into the slurry wall trench. The mix is pumped in as the trench is being excavated, thus protecting the trench walls from caving in. Picture (digital; Image 2193) was taken by Richard Ball on February 18, 2010.

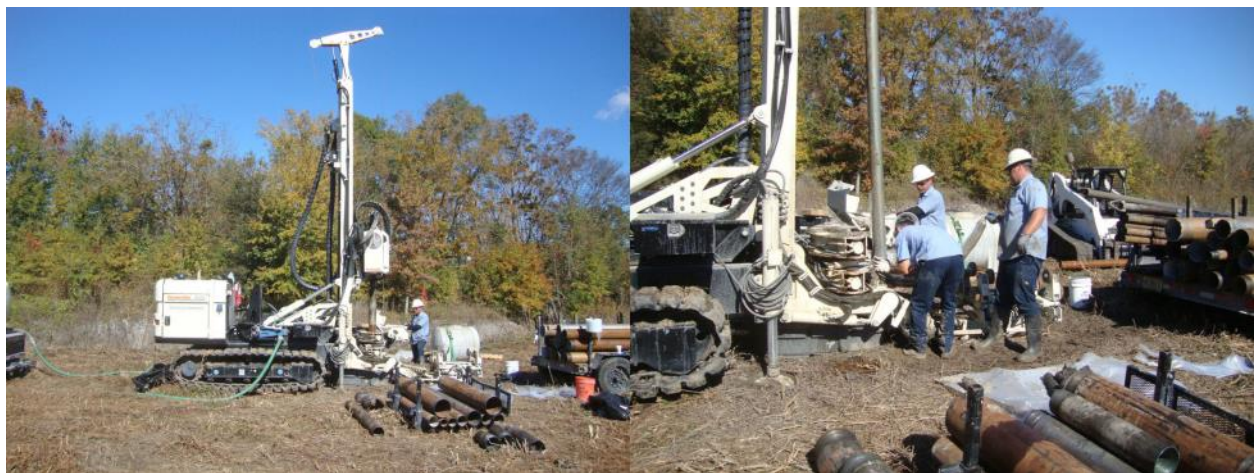
Figure 485. Full view of the small Geoprobe rotary sonic drilling rig at left and core retrieval at right, during drilling on the first core hole at the Southeastern Wood Preserving Superfund site at Canton, Mississippi. Pictures were taken on November 7, 2012.

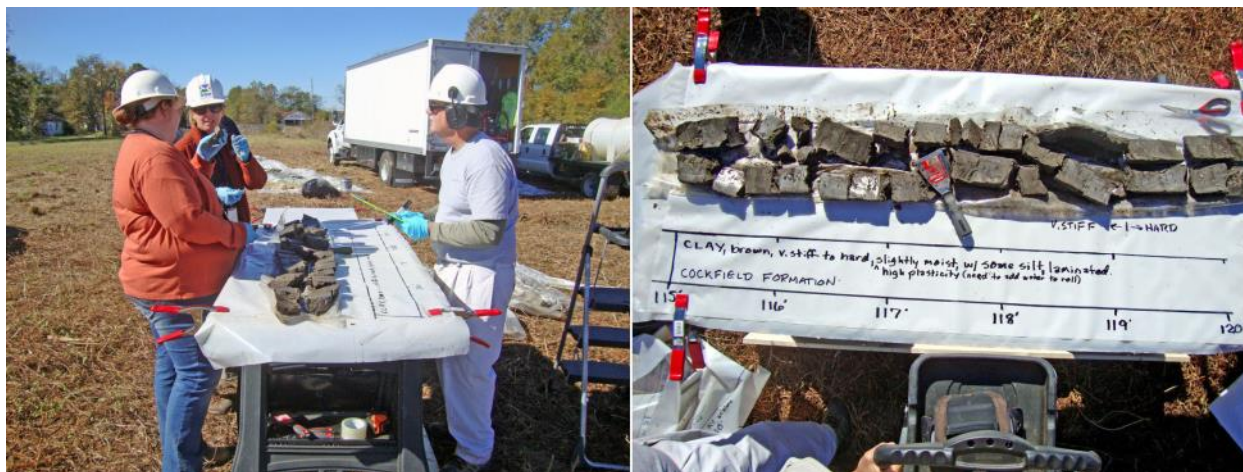
Figure 486. Geologists from Black & Veatch Special Projects Corp. examine a five-foot core of dark-brown clay from the upper Cockfield Formation from a depth of 115-120 feet below ground level. Pictures were taken on November 7, 2012.

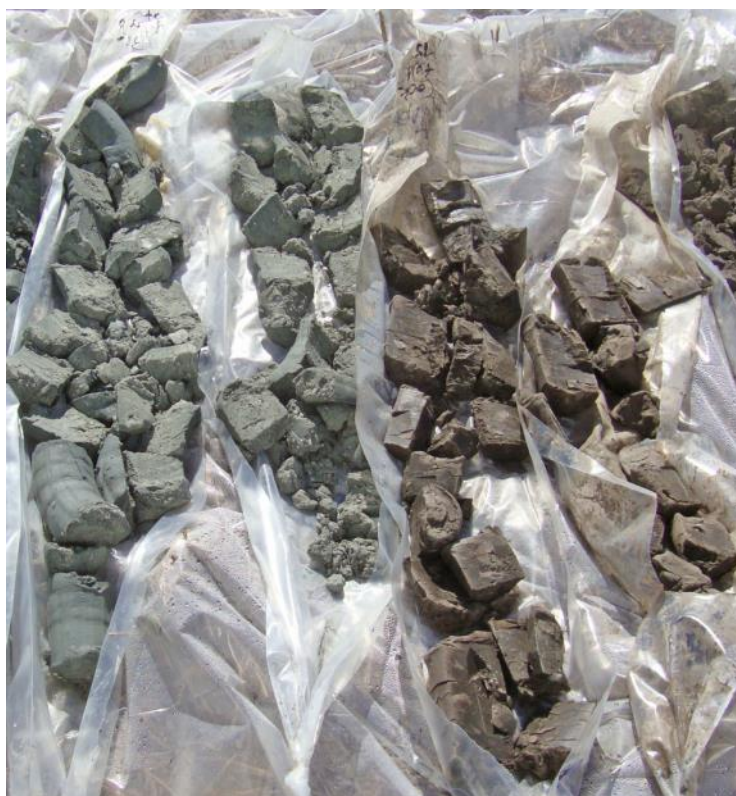
Figure 487. Moodys Branch Formation from 60-70 feet at right, and Cockfield Formation from 70-80 feet at right at the Southeastern Wood Preserving Superfund site in Canton, Mississippi. Pictures were taken on November 7, 2012.

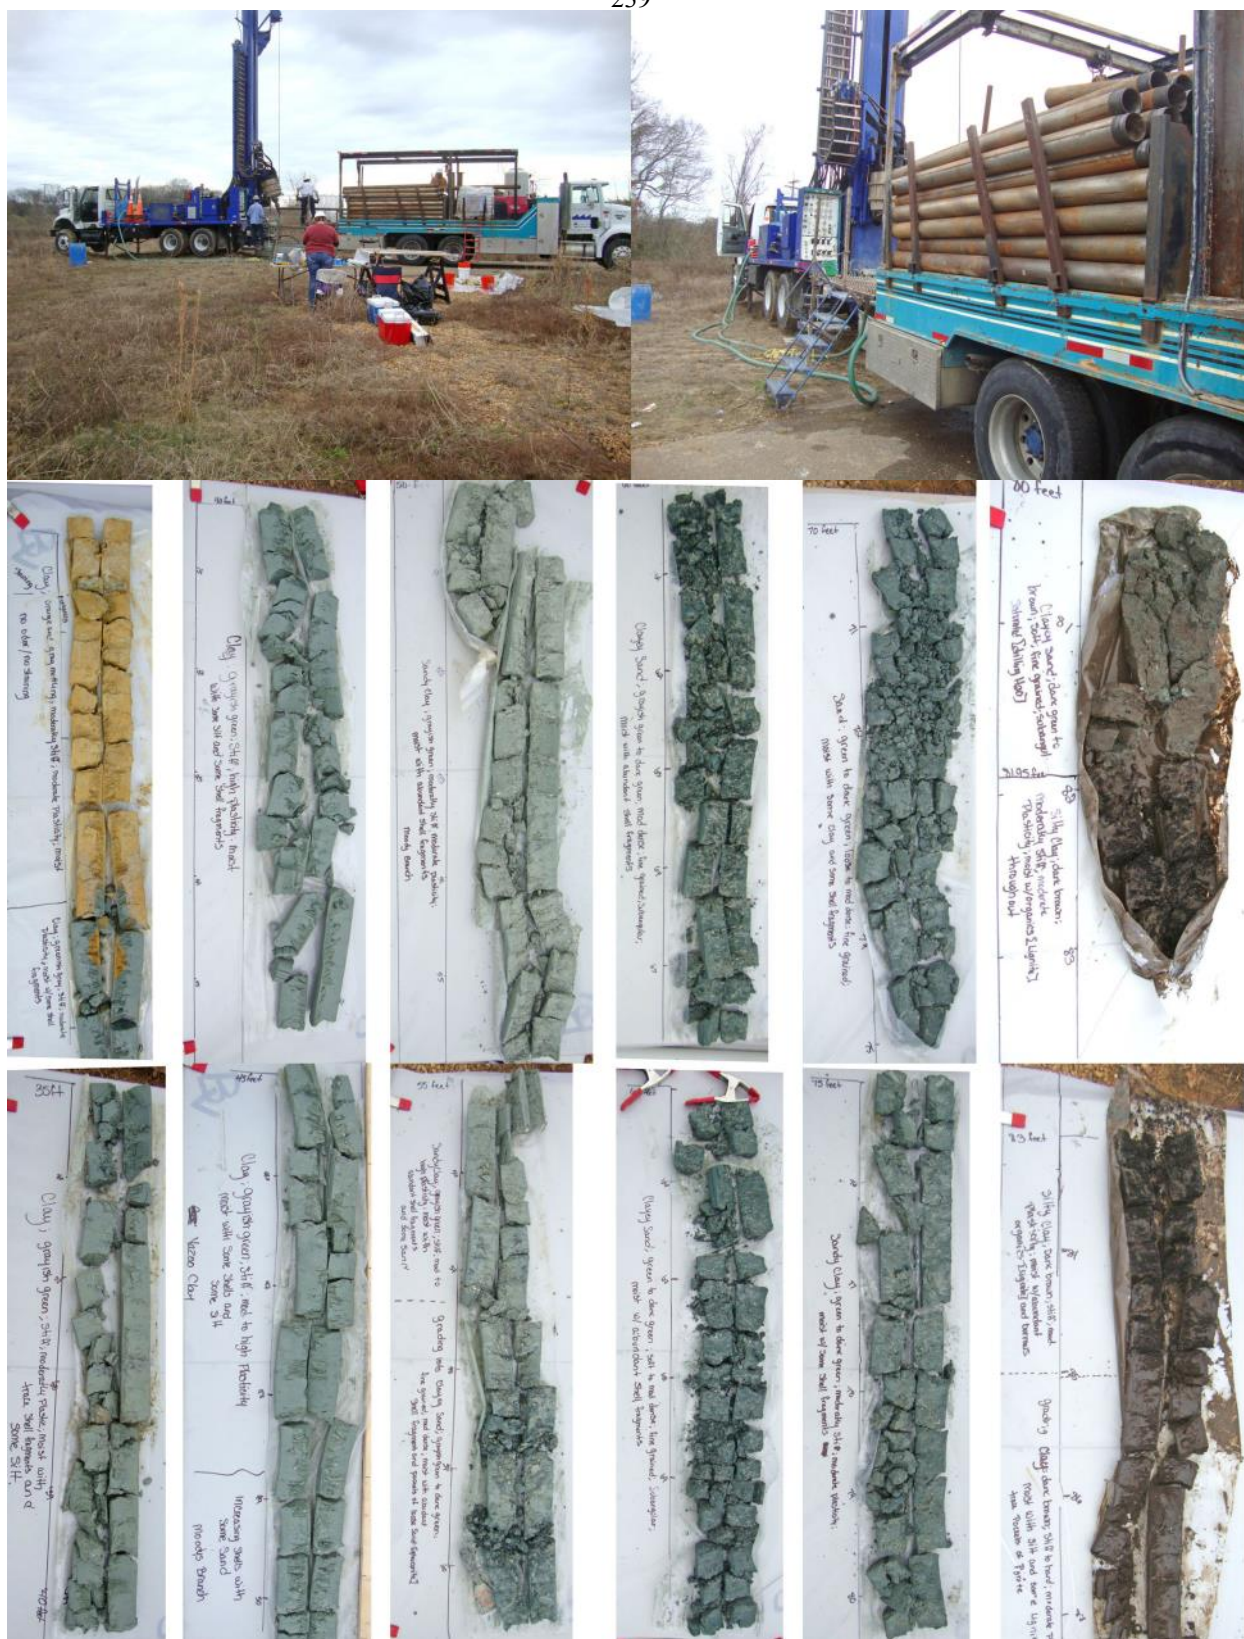
Figure 489. At top: Large rotary sonic rig drilling the second core at the Southeastern Wood Preserving Superfund site in Canton, Mississippi. At bottom: Ten-foot core intervals from left to right: 30-40 feet, 40-50 feet, 50-60 feet, 60-70 feet, 70-80 feet and 80-90 feet. The top of the unweathered Yazoo Clay is at 34 feet, the top of the Moodys Branch Formation is at 57.3 feet, and the top of the Cockfield Formation is at 81.9 feet. Pictures were taken on January 8, 2013.

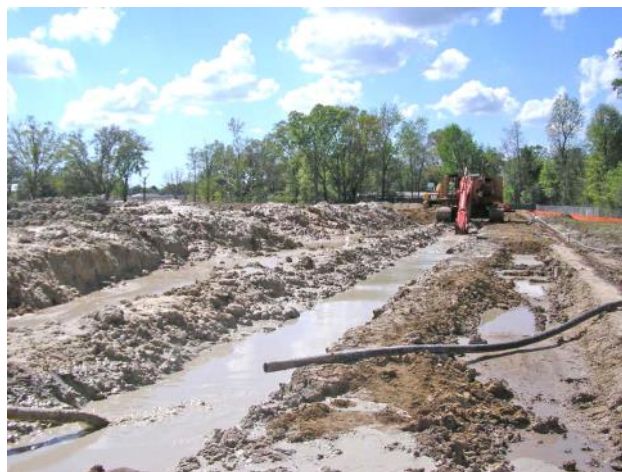
Figure 499. West cell slurry wall trenching at the Picayune Wood Treating Superfund site. Picture was taken by Michael Taylor in 2012. Image 2300.

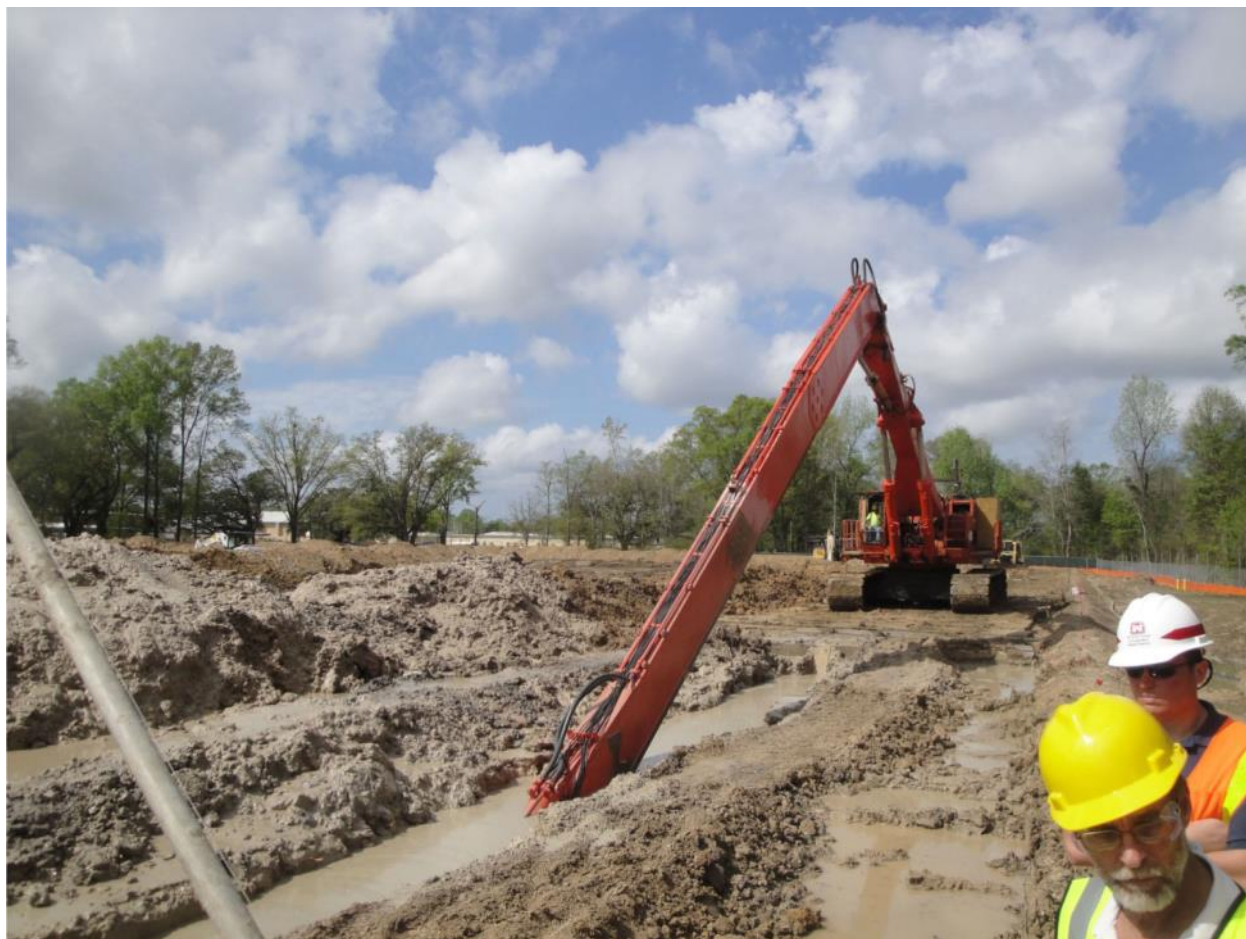
Figure 500. Long stick excavator excavating the west cell slurry wall at the Picayune Wood Treating Superfund site. Picture was taken by Michael Taylor in 2012. Image 2301.

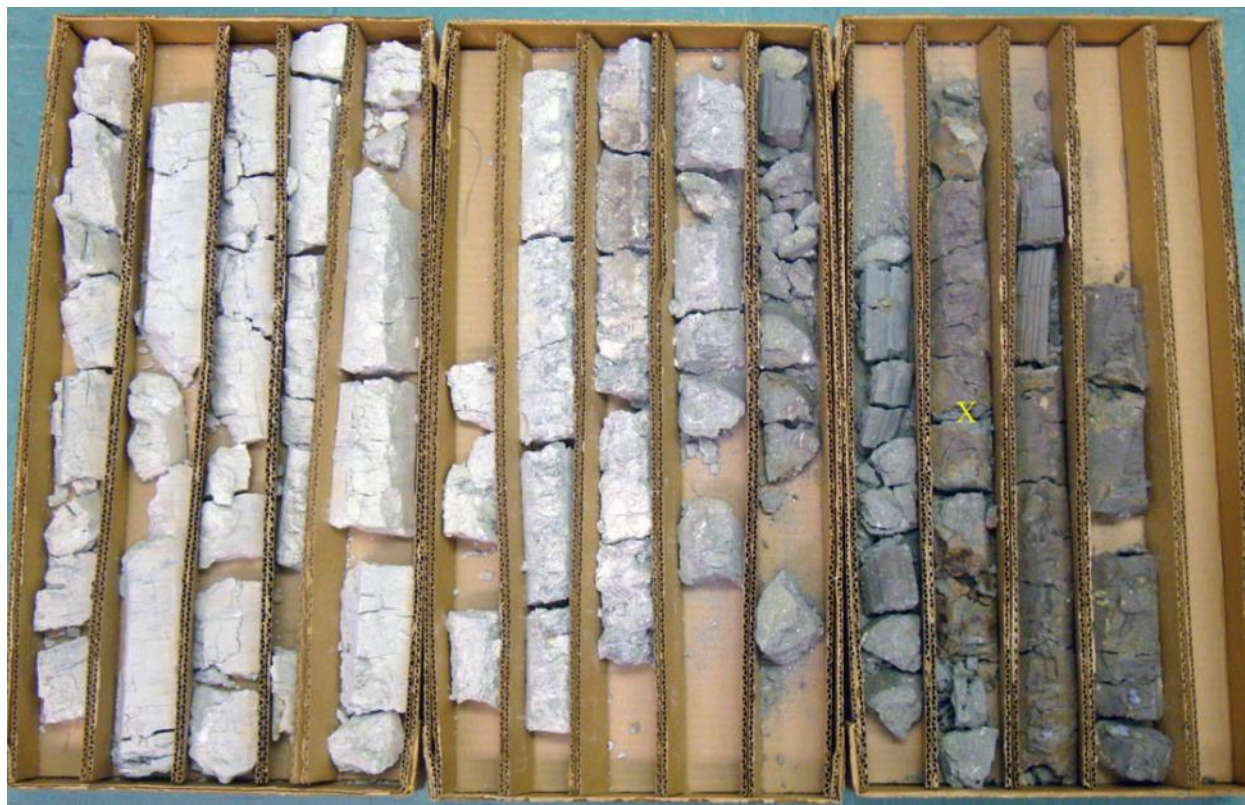
Figure 507. Core from a nearby location at the Mississippi Geological Survey building on 2525 Northwest Street, containing Yazoo Clay from 50 to 56 feet 8 inches below ground level in Box 1 at left; Moodys Branch Formation from 56 feet 8 inches to 70 feet 11 inches in boxes 2 and 3 ("X" marks the Moody Branch-Cockfield contact) and Cockfield Formation from 72 feet 11 inches to 76 feet.

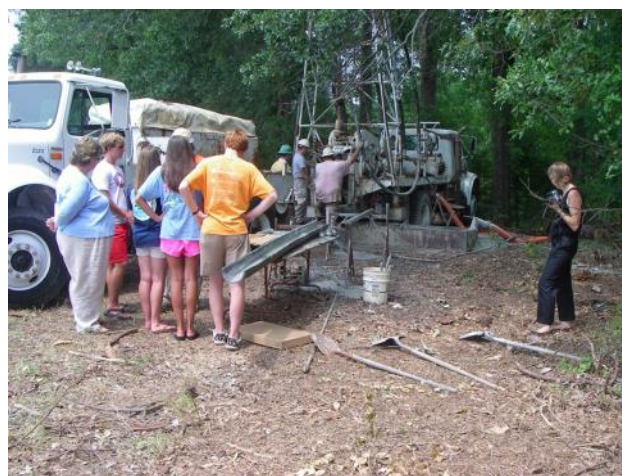
Figure 508. Students and teachers watch as the Office of Geology drills a monitor well in the Moodys Branch Formation at Jackson Preparatory School. Picture was taken on July 31, 2007.

John Marble of the Environmental Geology Division of the Mississippi Office of Geology recommended that the Moodys Branch Formation should be the first formation tested for surface pollutants that might penetrate the Yazoo Clay (**figures 505-507**). Marble had the concept of placing monitor wells in the Moodys Branch Formation at schools along the outcrop belt, where students could measure water level and learn about hydrology and protecting the groundwater from pollution. The first monitor well was installed at Jackson Pre-

paratory School in Flowood (**Figure 508**). Marble's recommendation was proven true at the ARAMARK site.

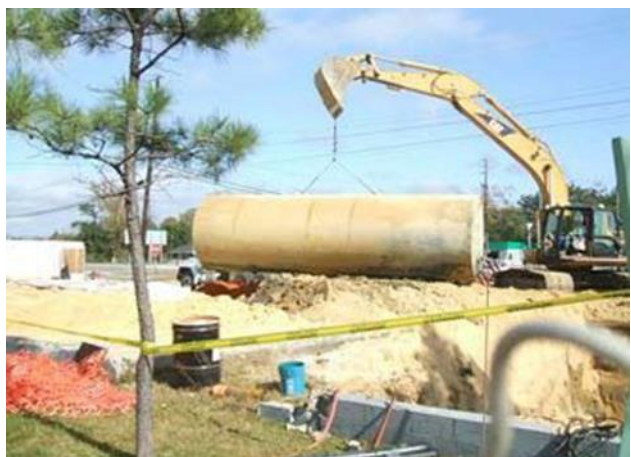
Figure 509. Underground storage tank removal at the former Swiftly Serve in Moss Point, Mississippi (picture from EPA).

Brownfield Assessment (TBA) funding from the Mississippi Department of Environmental Quality. This funding allowed the city to determine that the gas station's underground storage tanks were empty, though not properly capped. The city hired a contractor to remove the tanks and associated piping and to cap the property with clean fill (**Figure 509**). Roughly

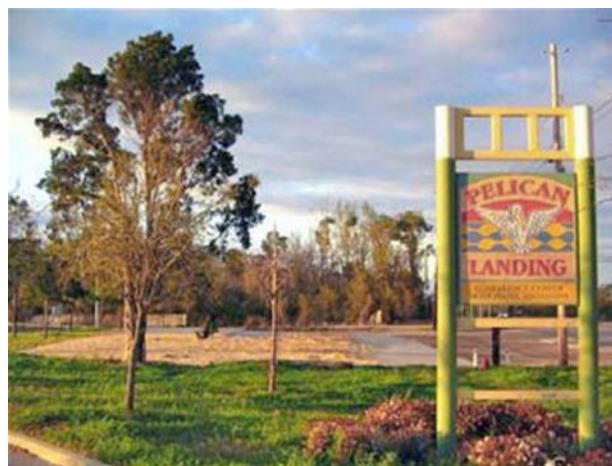
Figure 510. Reclaimed land at Pelican Landing Conference Center in Moss Point, Mississippi (picture from EPA).

\$60,000 worth of assessment and remediation was performed; the overall cost of the development of the conference center was on the order of \$3 million. Today the remediated site provides parking space for 100 cars at Moss Point's Pelican Landing Conference Center (**Figure 510**). In 2012, there were 23 Brownfields sites in Mississippi (**Figure 511**).

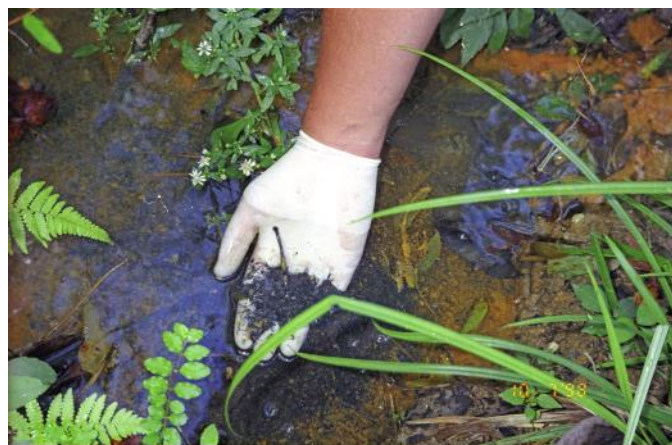
Figure 516. Hydrocarbon sheen and residue in a natural spring below the M & M Grocery store. Picture (color negative; Image 2215) was taken by Joseph Curro on November 7, 1998.

The gentleman's property contained a spring with a baffled cistern to hold water. The grandkids had been scooping the gas off the top of the water in the cistern for their three wheelers. Ball went immediately to the spring site and found it to contain 1 to 2 inches of gasoline floating above the water. Up the hill from the site was the M & M Grocery, which was both a store and service station. Ball informed the store owner of the gasoline leak; the owner referred him to Sheppard Oil Company who owned the gas pumps and underground tanks and who supplied them with gas. The owner also explained that the Sheppard Oil had been working on their system that

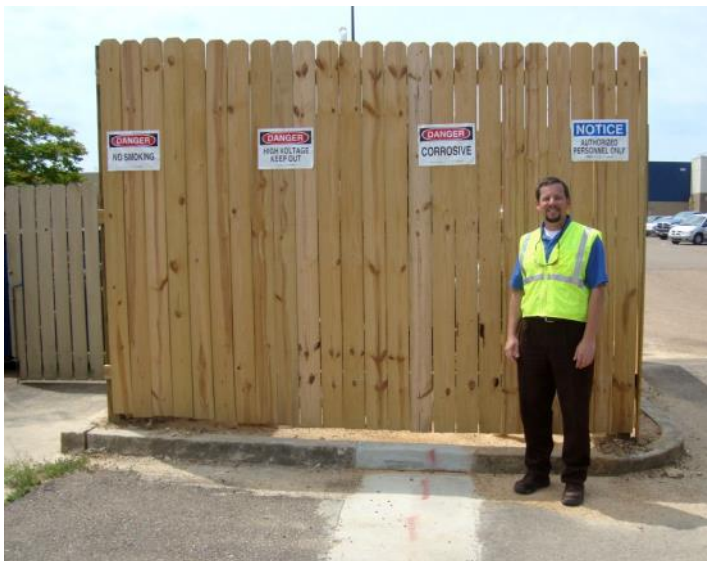
Figure 519. PPM Consultants geologist Charles Coney in front of the 8-foot high fence surrounding the company's mobile dual phase vacuum extraction system installed at the Murphy Oil USA #6857 Store in Clinton, Mississippi. The new strip of concrete leading to the enclosure covers: (1) a water pipe connecting the system to the storm water runoff drain, (2) plumbing for the vacuum/recovery pipes, (3) electrical lines, and (4) phone/monitoring lines. Picture (digital; Image 2224) was taken on April 10, 2012.

In 2012, a mobile dual phase vacuum extraction system (DPVE) with a 7.5-horsepower motor was installed at the site and connected to two recovery wells in the tank bed in order to recover residual hydrocarbons. Hydrocarbon vapors were vented to the air, and purified water was piped to the storm drain. An eight-foot high wooded fence was placed around the vacuum extraction system (**Figure 519**). **Figures 520-521** show the above-ground plumbing and vacuum gage connected to the DPVE system. **Figure 522** shows the interior of the mobile system.

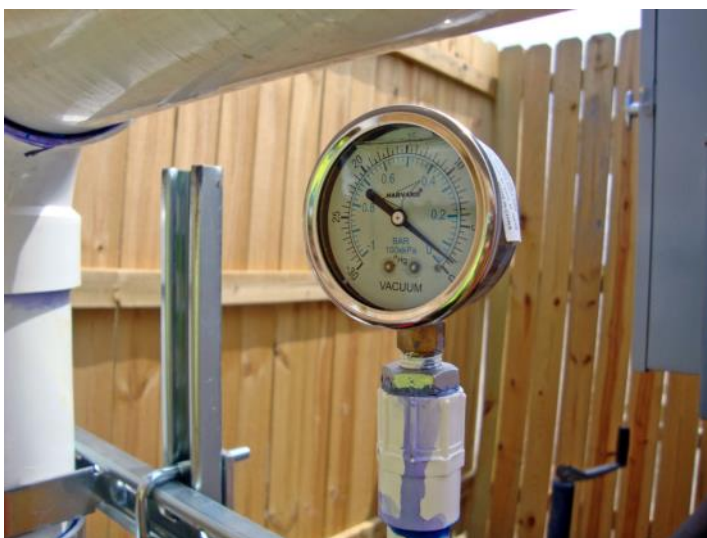
Figure 521. Pressure gauge for vacuum lines leading to the mobile dual phase vacuum extraction system at the Murphy Oil USA #6857 Store in Clinton, Mississippi. Picture (digital; Image 2226) was taken on April 10, 2012.

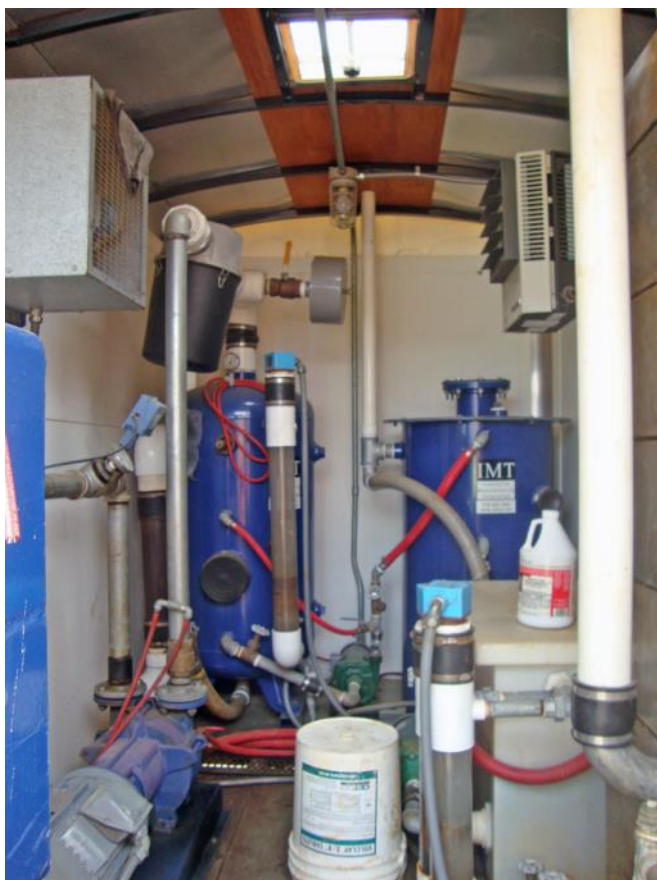
Figure 522. Interior of the mobile dual phase vacuum extraction system at the Murphy Oil USA #6857 Store in Clinton, Mississippi. Picture (digital; Image 2227) was taken on April 10, 2012.

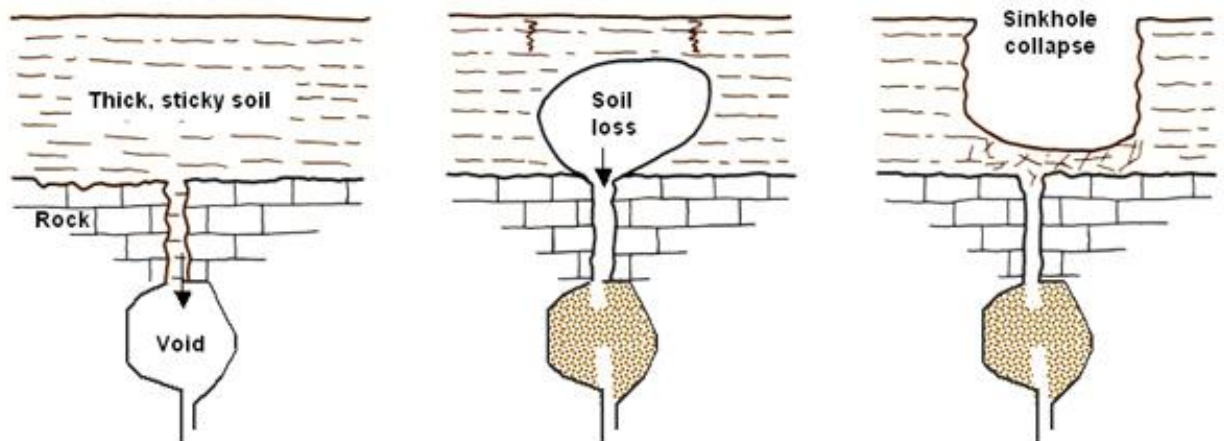
Figure 526. Development of a sinkhole in soil overlying a solution void in limestone bedrock.

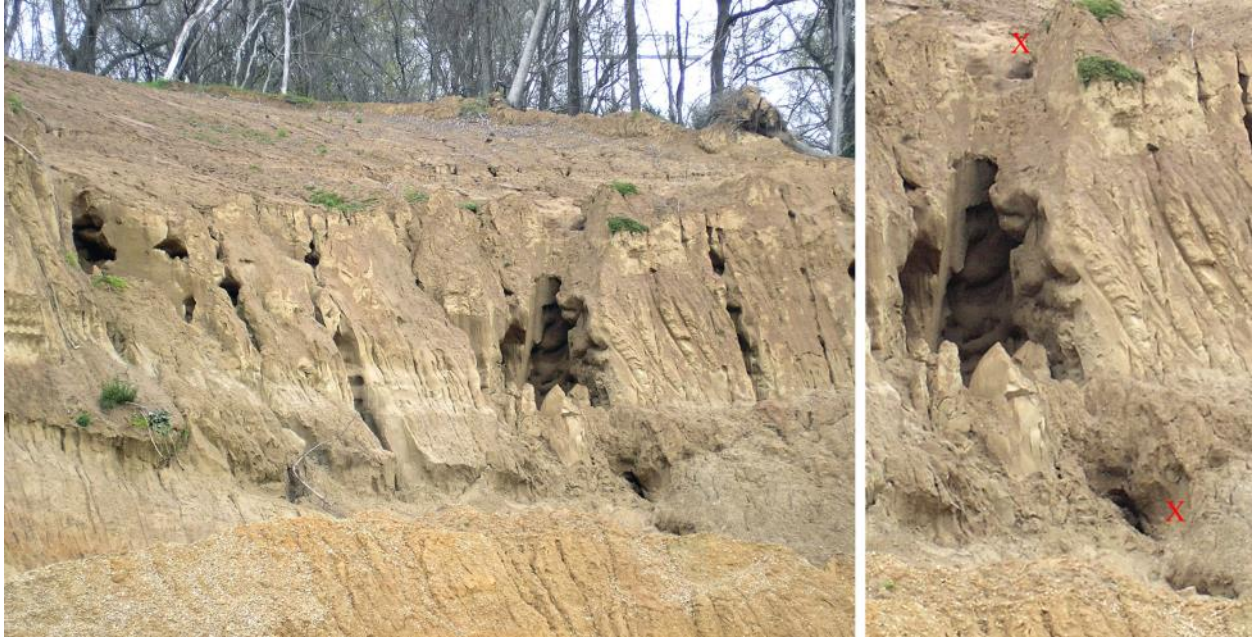
Figure 527. Left, cavernous loess uncovered in the high wall of a dirt pit on Old Highway 61 in Vicksburg, Mississippi. Right, red X at top marks the opening of a “rabbit hole” leading downward to a loess cavern; the lower red X marks a lateral drain leading from the cavern. Pictures were taken by James Starnes on March 22, 2013.

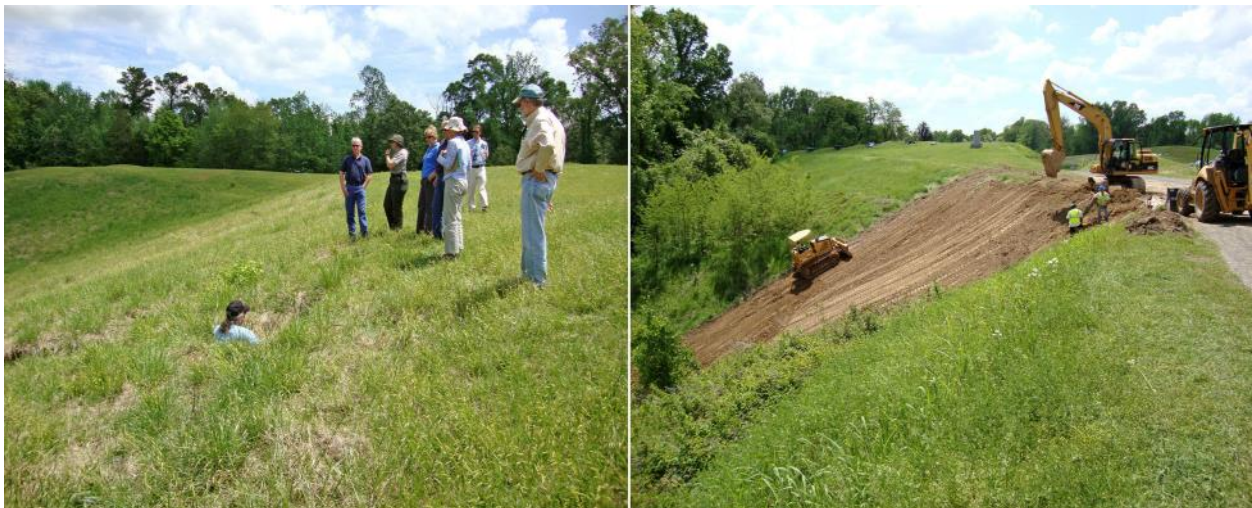
Figure 528. Left, man standing in a sinkhole up to his shoulders at the Vicksburg National Military Park as National Park Service staff and Mississippi Office of Geology personell watch. Right, heavy equipment repairing a slope in the Park. Pictures were taken on April 14, 2010.

Sinkholes also develop in the loess soils of the Loess Hills bordering the east side of the Mississippi River Valley. I have such sinkholes where I live in northwestern Hinds County. The trick is to remember where they are and straddle them with the tractor while mowing (so that I don't fall in and break an axle). I tried to fill one of the larger holes with a dump-truck-load of dirt. The dirt went somewhere, and the hole came back. Since then the sinkhole has taken out a pear tree, while working its way up the hill toward my house. Now we use it as a convenient dump for kitty litter in an effort to reach parity with the hole's insatiable appetite for dirt. The left side of **Figure 527** shows cavernous loess in the high wall of a dirt pit on Old Highway 61 in Vicksburg; the right side shows a "rabbit hole" (like the one in *Alice in Wonderland*) leading downward to a loess cavern with another lateral hole draining the cavern. A golfer standing above a slightly covered "rabbit hole" could suddenly find himself eighteen feet below ground at the bottom of a loess cavern. The National Park Service regularly deals with sinkholes and erosion while keeping up the grounds on the loess terrain of the Vicksburg National Military Park. The beautifully manicured slopes require periodic maintenance with heavy dirt-moving equipment (**Figure 528**).
